**Newland Homes Limited**

**PRE-DEVELOPMENT TREE SURVEY AND CONSTRAINTS**

**LAND NORTH OF COLLIN LANE, WILLERSEY**

Date: 22<sup>nd</sup> September 2017

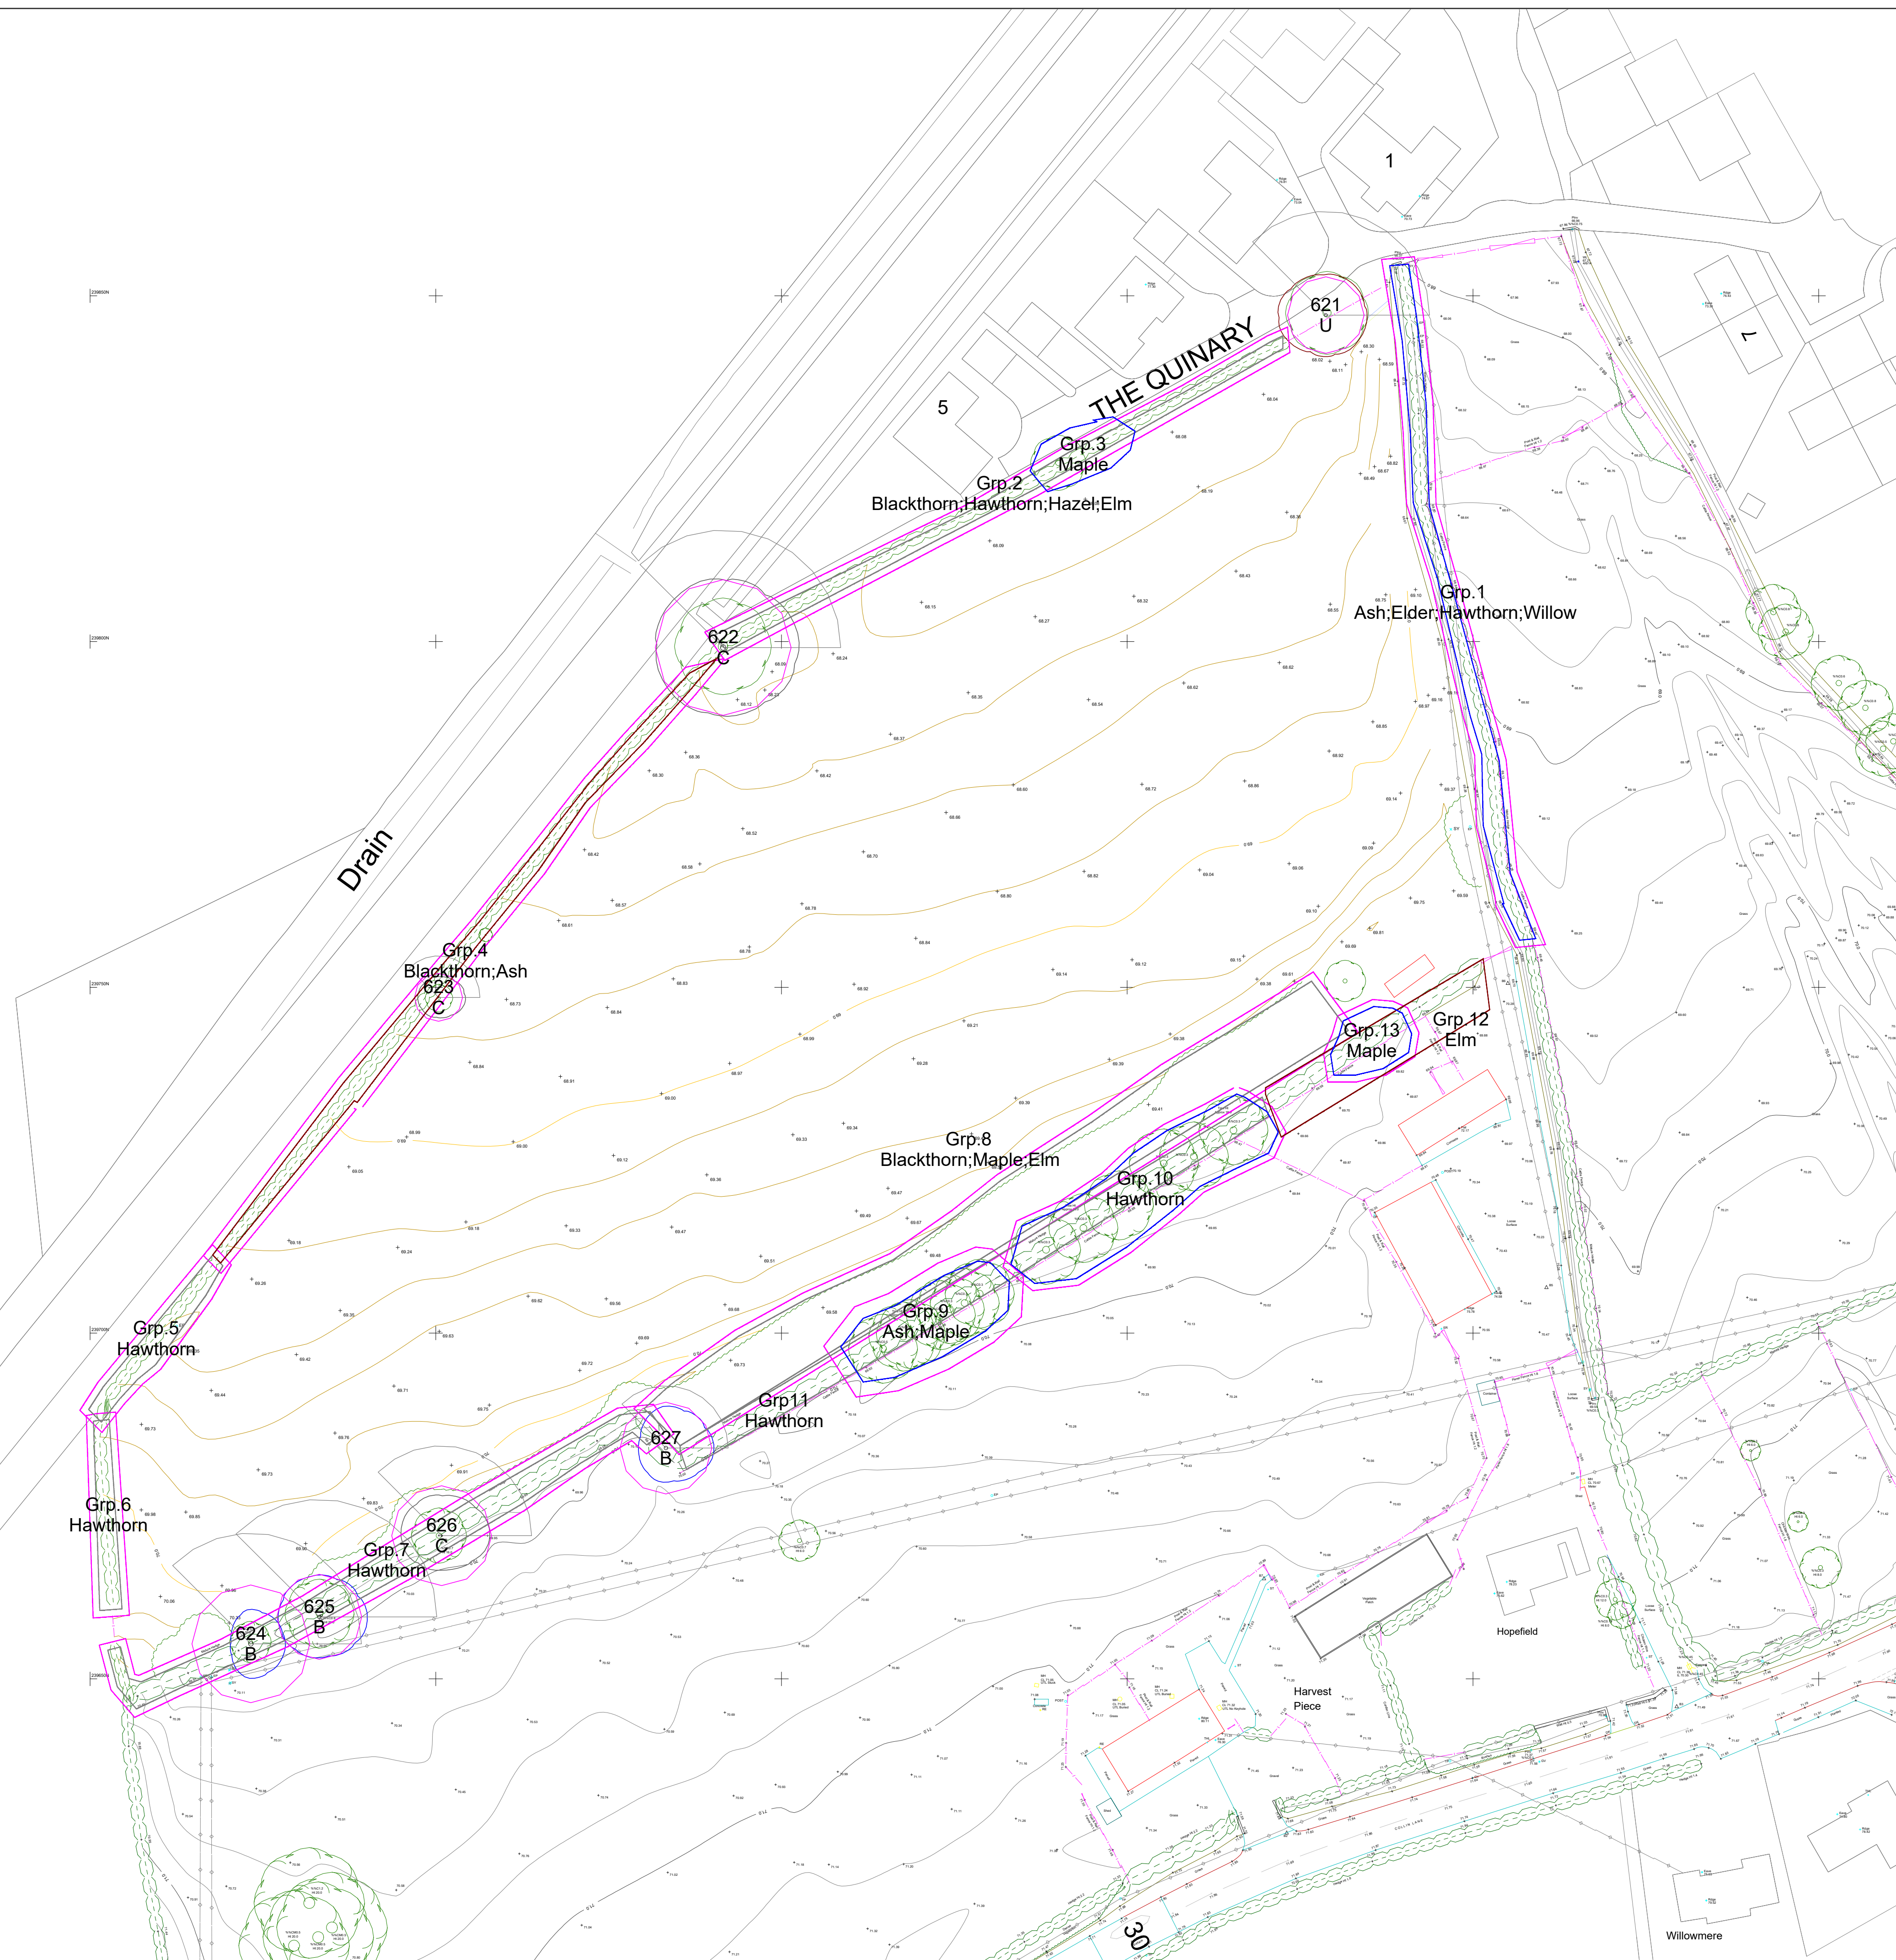
## **APPENDIX 2. TREE SURVEY AND CONSTRAINTS PLAN 13346/56175**

- 5.1.1 Below ground constraints (Root Protection Areas (RPAs)) are shown on the tree Survey and Constraints Plan 13346/56175 (Appendix 2). This is the minimum area which should remain undisturbed and protected from construction activity. At this stage it is represented as a circle centred on the trunk of each tree. Groups of small trees are shown with root protection areas 1 metre outside the plotted canopy; groups of large trees are based on the largest stem diameter within the group to ensure sufficient space has been provided. As a default position, construction, services and working space should not be required within the RPAs of retained trees.
